EARTHQUAKE INDUCED FISSURING IN BANKS
PENINSULA LOESSIAL SOILS: A GEOTECHNICAL
INVESTIGATION OF THE RAMAHANA ROAD FISSURE
TRACE

A thesis submitted in partial fulfilment
of the requirements for the Degree of
Master of Science in Engineering Geology
In the Department of Geological Sciences
University of Canterbury

Christopher Stuart White

2016

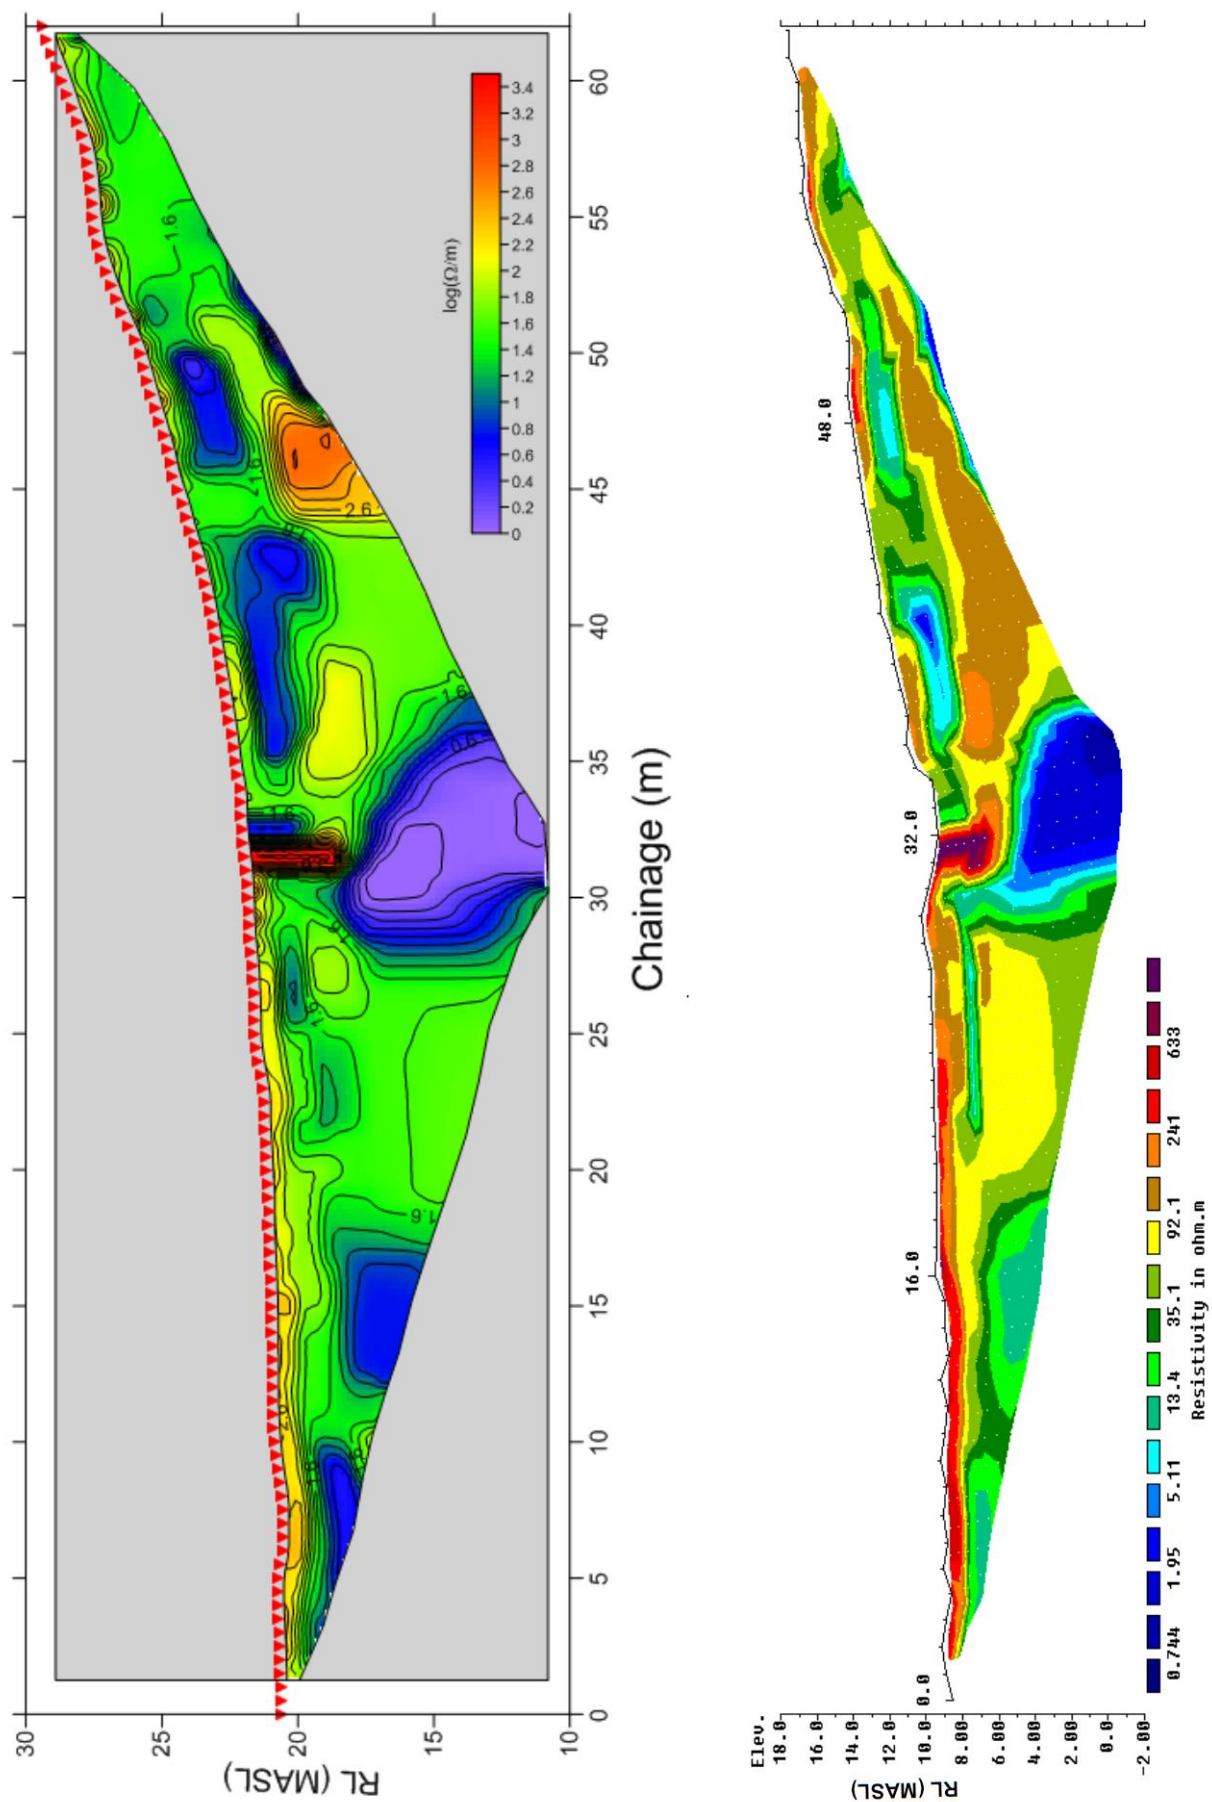
Figure 3.13: Comparison of different electrical resistivity geophysical models for the same survey at 17 Ramahana Road. The resistivity anomaly in the centre is consistent in both models. Refer to Figure 3.5 for survey line.

The most striking features of the resistivity survey are in the center of the diagram where there is a large area of relatively conductive soil below and to the east of a relatively resistive area of soil. The highly conductive area is at its highest conductivity ($0 \log \Omega/\text{m}$) at the chainage of 37m near the extent of survey depth. The highly resistive area is at its highest resistivity ($3.4 \log \Omega/\text{m}$) at the chainage of 33m from the soil surface to a depth of 4m below ground level. This high resistivity area continues westward at depth into the slope, although the resistivity reduces to the west.

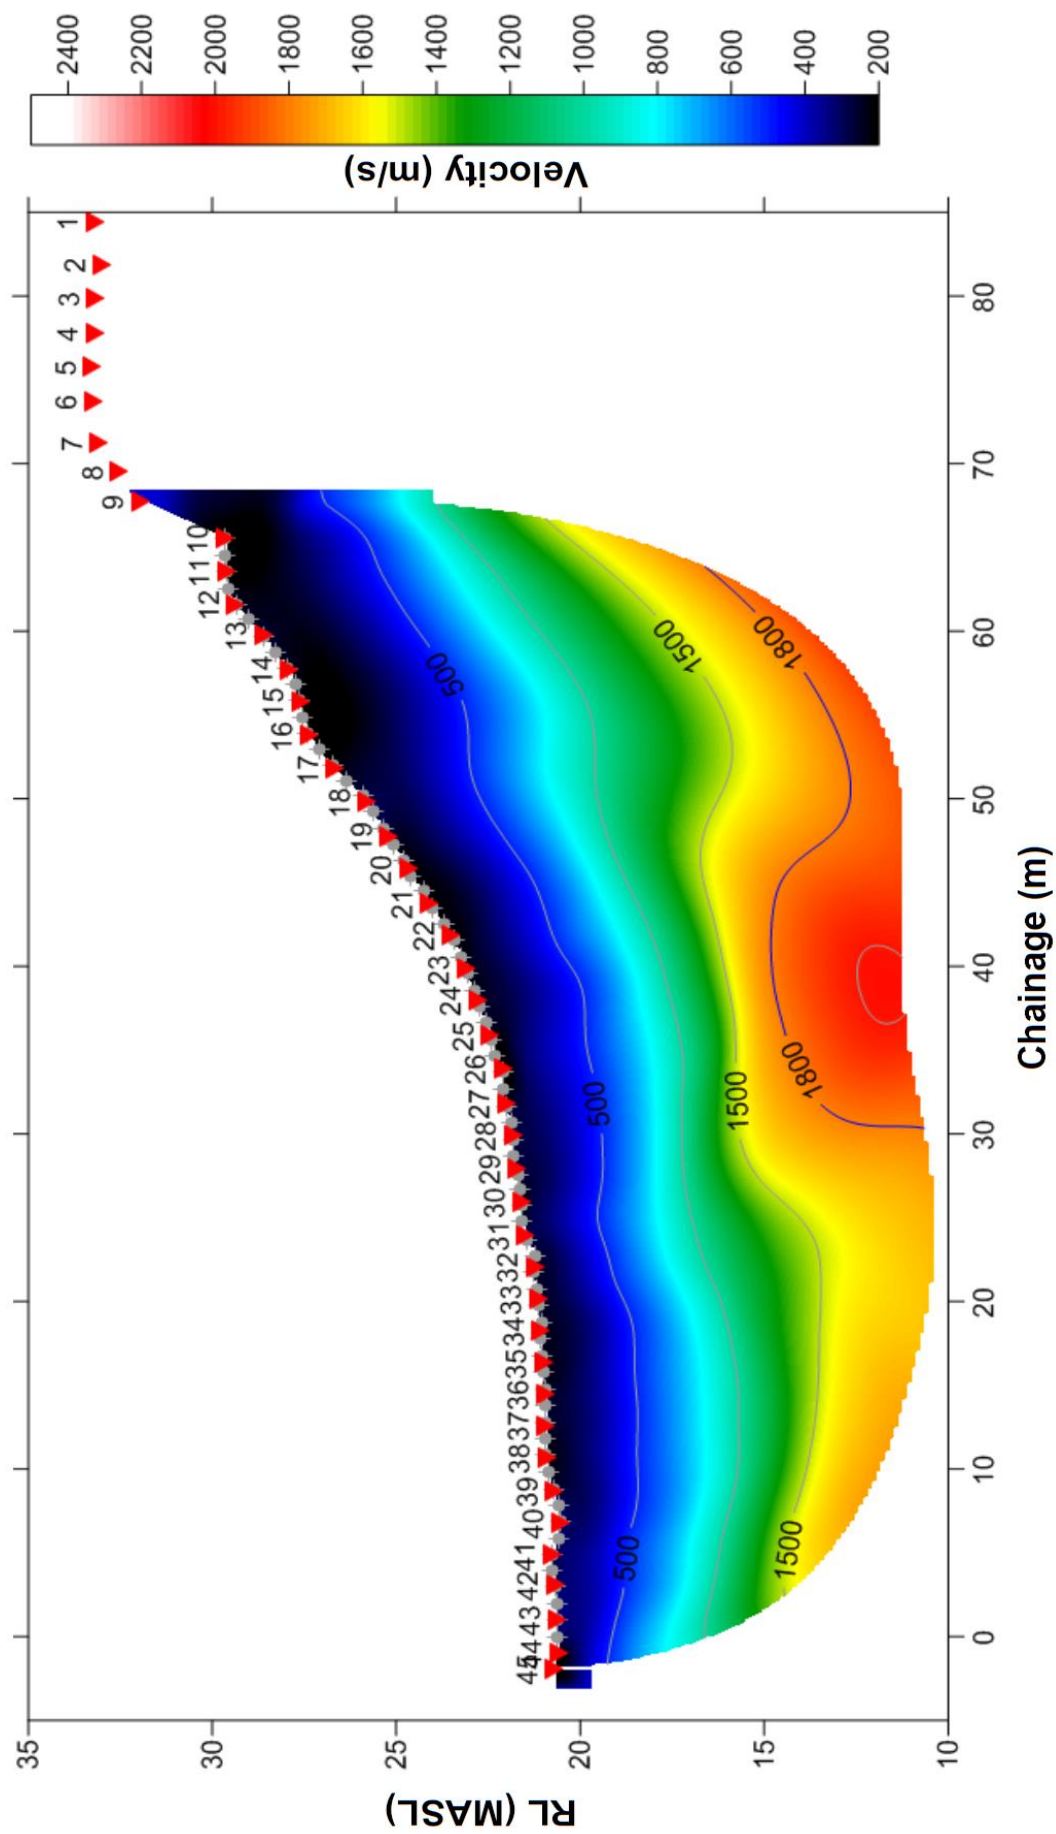
Figure 3.14: Final interpreted model of the seismic reflection survey for 17 Ramahana Road with topography at 2 x vertical exaggeration. Note that the blue contour = water velocity.

The geophones were spaced at 1m from the upper westernmost point of the property on the far side of Ramahana Road to below the easternmost point on the property within St Martins School. Appendix 2.5 shows the initial model and raypath model. The final model can be viewed in Figure 3.14, and it shows increasing density with depth, which is what is expected considering the soil profile identified in the borehole logs from the site. There is 2x vertical exaggeration in this model.

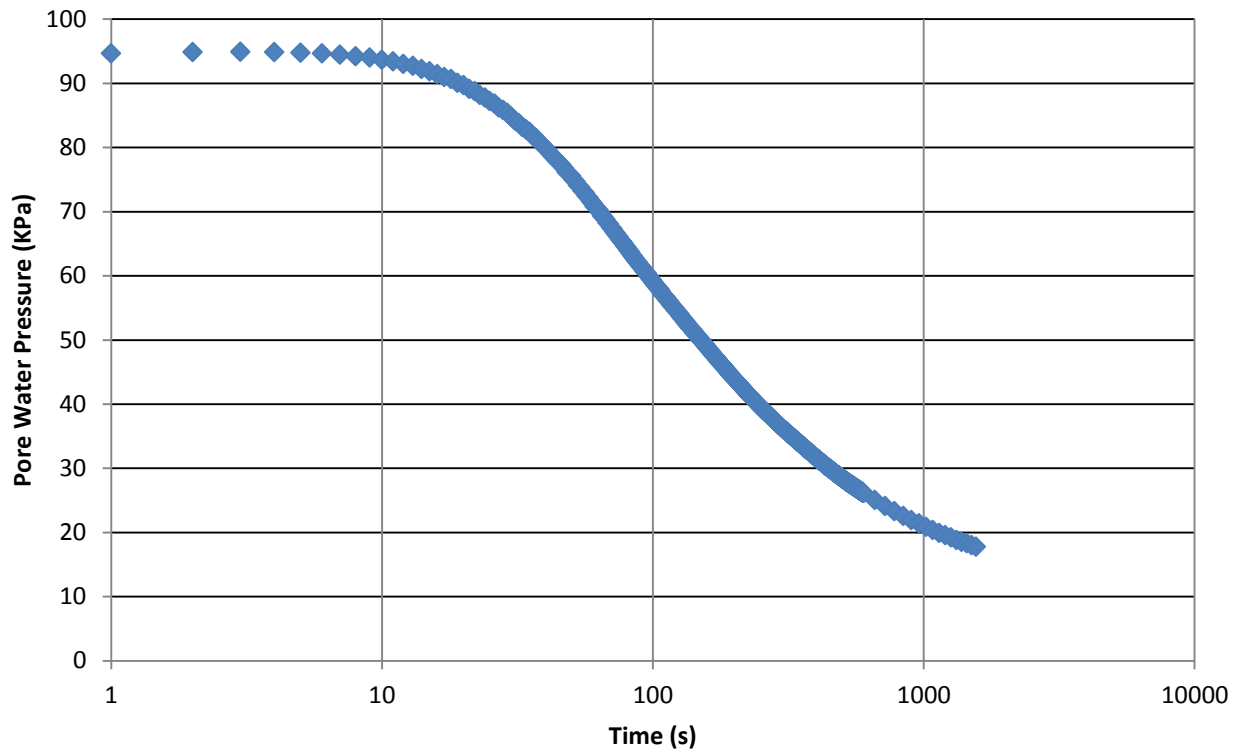
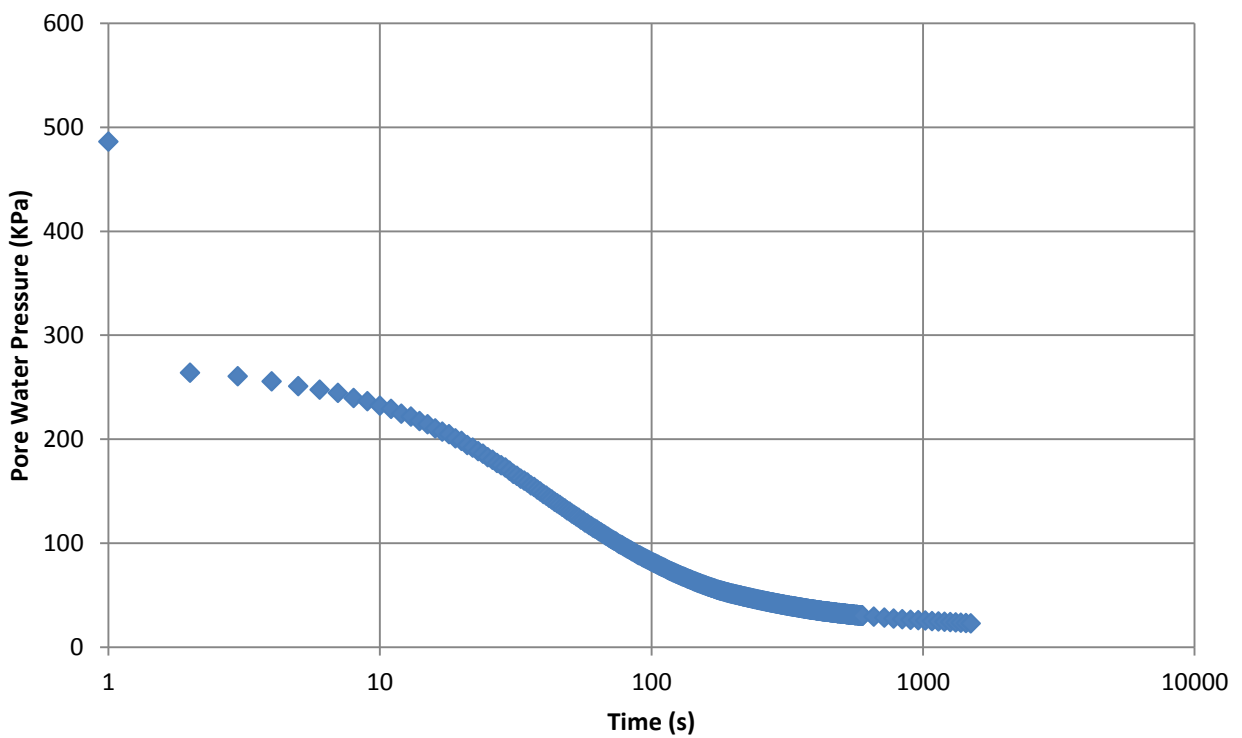
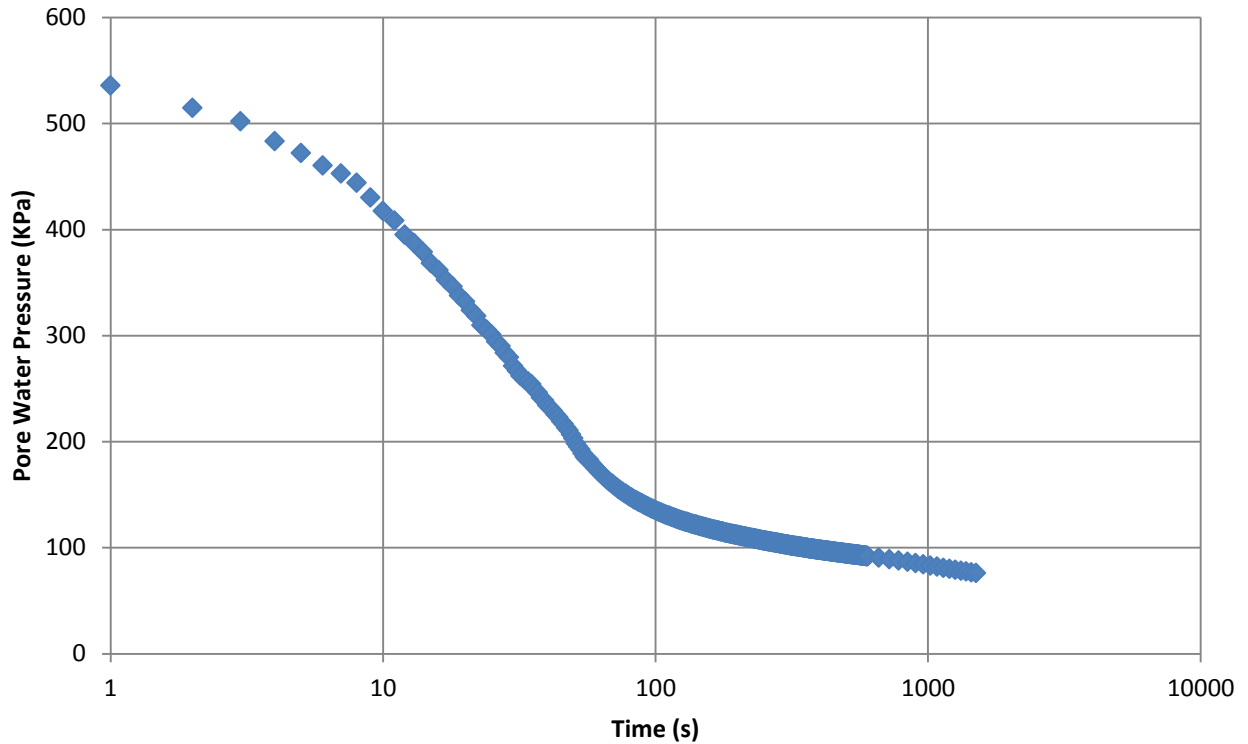
Figures 3.17-3.19 show the pore pressure dissipation tests at 9.00m-13.0m. The pore pressure reached its highest point at 13m where it reached a value of 536KPa; this is 7 times greater than its hydrostatic pressure of 76.1 KPa. The second highest pore-water pressure was found at 11m where it reached 486.3 KPa; however this value dropped to 263.8 KPa within 1 second of the cone reaching a static state. The hydrostatic pressure was 22.9 KPa, which means the pore-water pressure reached 22.2 times its hydrostatic pressure when subjected to monotonic loading, but dropped to only 11.5 times its hydrostatic pressure within 1 second. The lowest pressures were found at 9m where the pressure reached 94.6 KPa, which was 5.3 times its hydrostatic pressure of 17.8 KPa. All of the pore pressure dissipation tests reached their equilibrium pressure within 25 minutes regardless of how high the pore-water pressure reached in the first instance.

These results show that there is potential for pore pressure increase in the loess-colluvium at 17 Ramahana Road under monotonic loading. The potential increase varies depending on the coefficient of consolidation, natural moisture content, and permeability of the soil. It is currently unknown what effect cyclic loading would have on pore pressures, but it is hypothesized that the pore pressure increase would be more substantial than under monotonic loading. Because the pore pressures in the loess-colluvium at 17 Ramahana Road increase under monotonic loading, then if liquefaction were to occur in the deposit during an earthquake, it should present itself as flow liquefaction rather than cyclic mobility.

Figure 3.17: Pore pressure dissipation test at 9.00 m depth in CPT-17RMH-01.

Figure 3.18: Pore pressure dissipation test at 11.00 m depth in CPT-17RMH-01.

Figure 3.19: Pore pressure dissipation test at 13.00 m depth in CPT-17RMH-01.

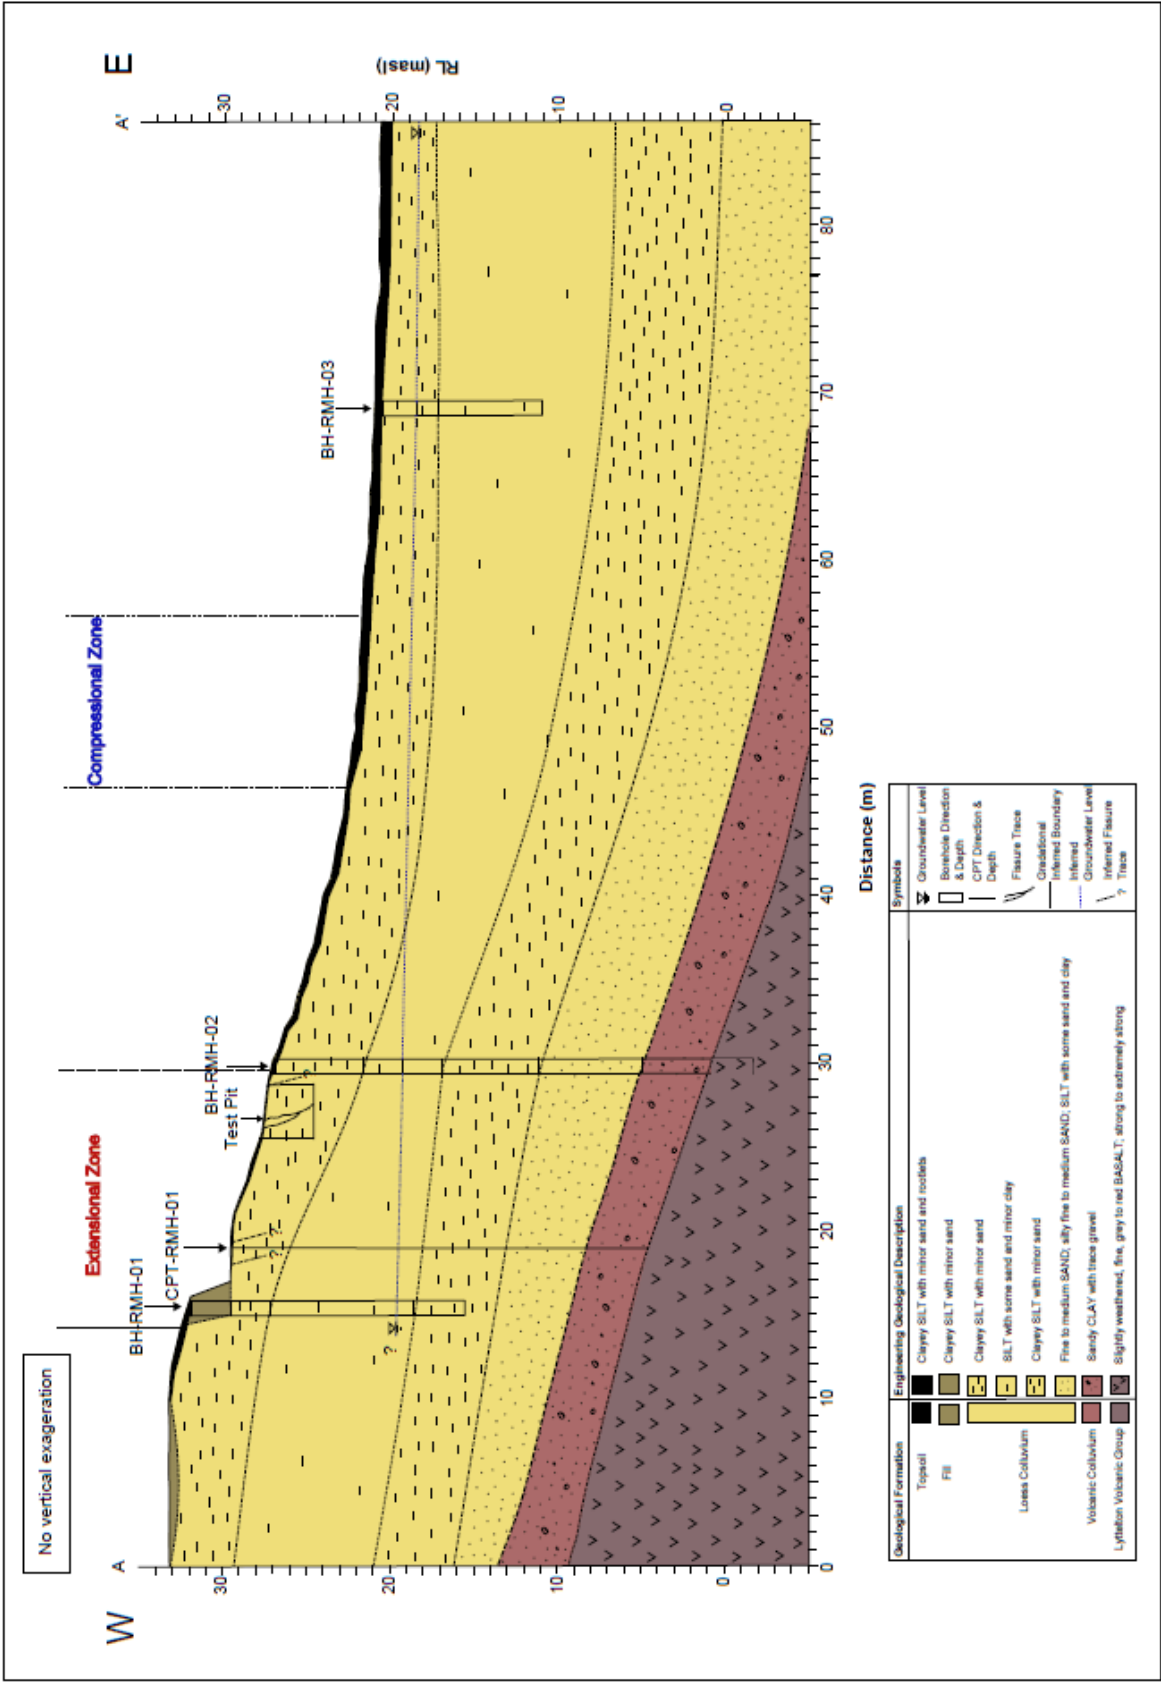
The cross-section line for the 17 Ramahana Road cross-section is shown in Figure 3.20. This diagram has no vertical exaggeration and was created by interpretation of the three boreholes logged by Tonkin and Taylor Ltd: BH-RMH-01, BH-RMH-02, and BH-RMH-03, the CPT profile, the test pit, the geophysical surveys, and surface engineering geological mapping.

The water level was determined by dip test in the piezometers installed in BH-RMH-02 and BH-RMH-03, and by the moisture content of the soil in BH-RMH-01. It needs to be stressed that these are only considered to be water level readings and not necessarily indicative of the water table: they could simply represent perched water, a layer of particularly saturated loess-colluvium, or artesian pressure from the bedrock, because the screen depths are unknown.

The extensional zone and compressional zone have been assessed from the mapping done by Massey et al. (2013), and from the engineering geological mapping done in this study. The translational zone has been omitted due to its presumption that the fissures are the head-scarps of landslides, when there is not sufficient evidence to suggest that this is so at this stage.

Figure 3.20: 17 Ramahana Road deep site model. Note that the water level line may not be indicative of the water table, because the depth of screen for BH-RMH-02 and BH-RMH-03 are unknown. Refer to Figure 3.5 for cross-section line and Appendix 2.8 for the borehole logs.

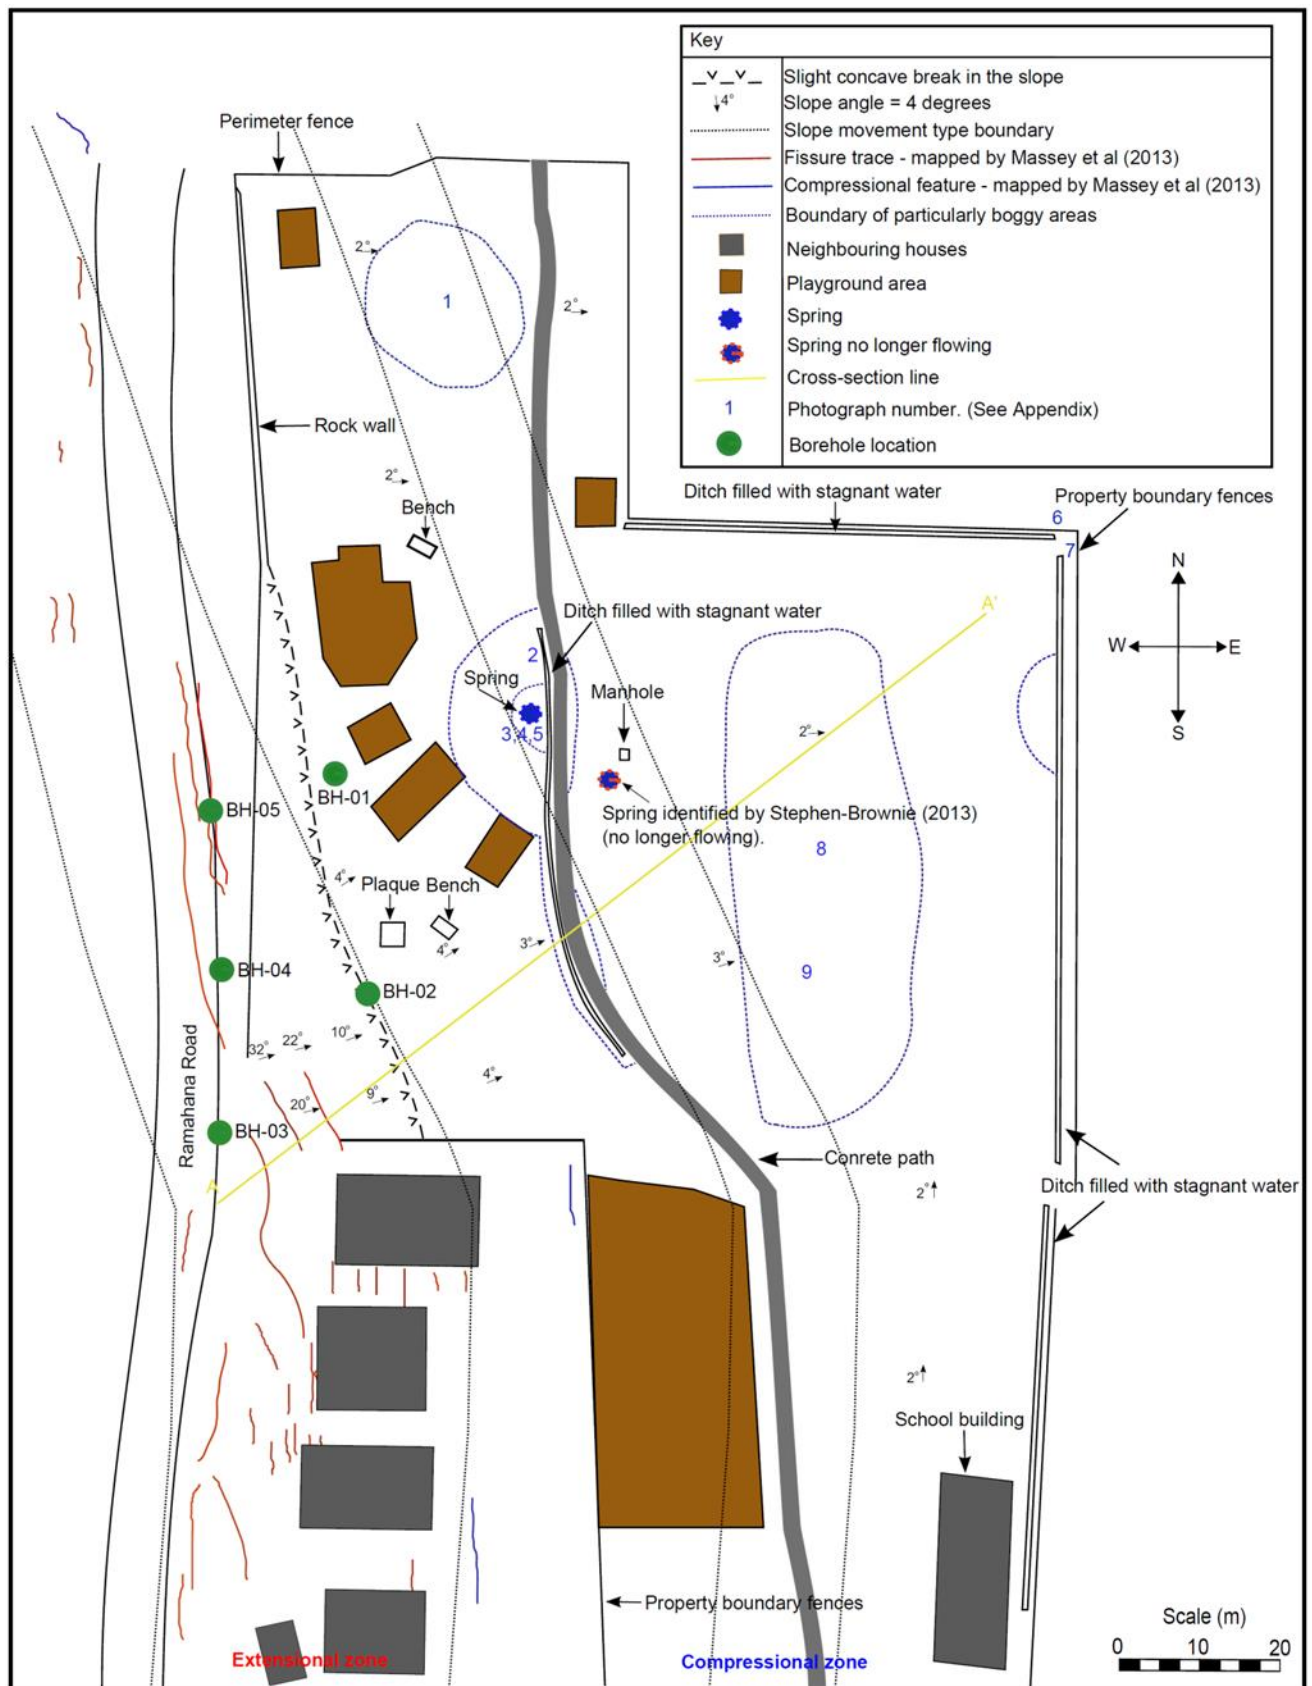
The engineering geological map of Centaurus Park is presented in Figure 3.21. This was mapped on the 4th of August 2015, during winter, so the mapped boggy areas may have been larger than the average extent of surface saturation. There are three main areas of boggy ground on the park, but only the central one, near the path, has observable spring flow. The spring flow is bringing fine sediment to the ground surface which is slowly building a small mound of loose sediment near the path. The boggy areas have shallow stagnant water up to 30mm deep in localized hollows. There had not been significant rainfall in the time prior to the mapping.

Figure 3.21: Centaurus Park engineering geological map. Refer to Figure 3.23 for cross-section, Appendix 2.9 for mapping photos, and Appendix 2.10 for borehole logs.

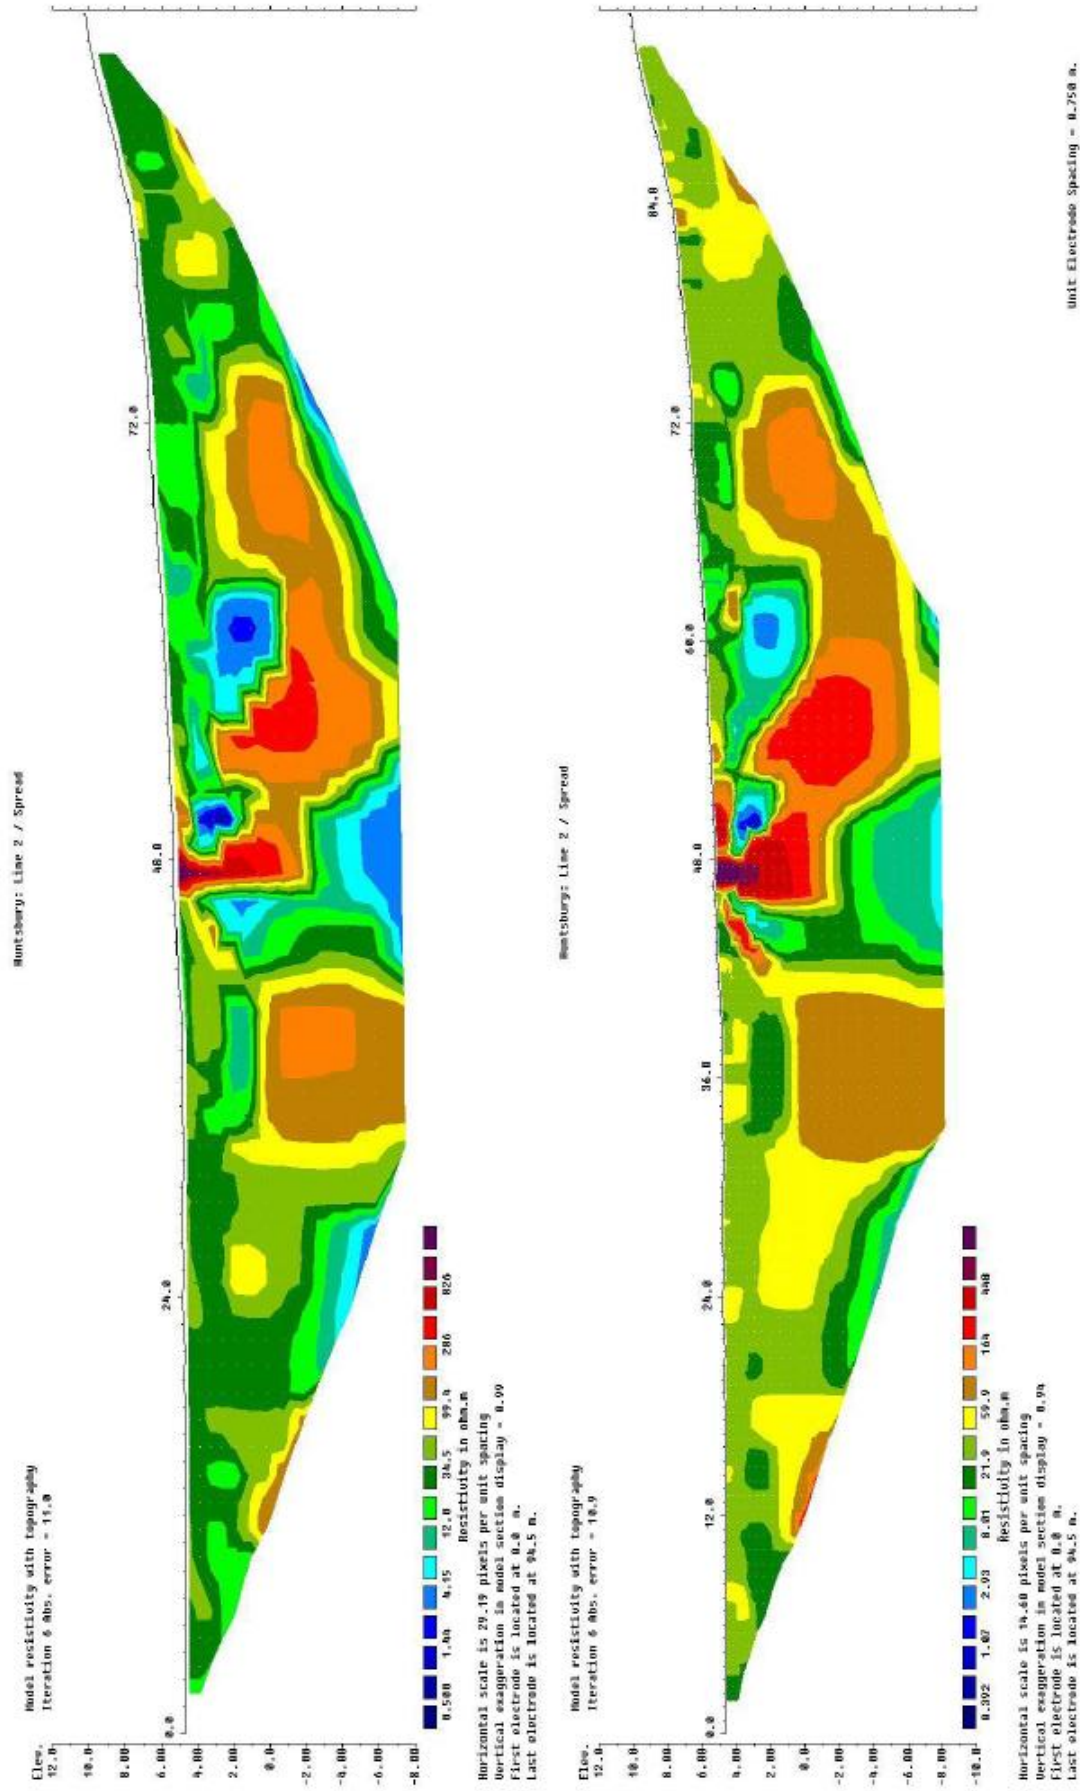
Figure 3.22 displays the electrical resistivity geophysical survey done by Stephen-Brownie (2012) at Centaurus Park, and the results are remarkably similar to the results at 17 Ramahana Road. There is the same high conductivity area in the centre of the survey, with a high resistivity area above and upslope. The high resistivity area continues at 2-12m below the ground surface westward into the slope and there are perched high moisture content areas above this. The high conductivity area also appears to bend around the compressed area towards the ground surface.

There was no compressional zone identified in Centaurus Park in the mapping done by Massey et al. (2013), but there were springs identified by Stephen-Brownie (2012). It was interpreted that the high conductivity area in the centre of the survey was related to saturation from the newly formed spring system and the high resistivity area was related to a colluvium layer within the loess; however it is now understood that the soil is loess-colluvium.

Figure 3.22: Comparison of models from the electrical resistivity geophysical survey for Centaurus Park, from Stephen-Brownie (2012). The resistivity anomaly in the centre is consistent for both models. Refer to Figure 3.22 for survey line.

The high resistivity area in the centre of the diagram is hypothesized to be related to compression of the soil, but this compression may not have been observable at the ground surface in Centaurus Park. Most of the compressional features on this side of the valley have been observable through cracks in concrete and tilted infrastructure, but because Centaurus Park is largely an open area, the compression of the soil may not have been observable at the ground surface.

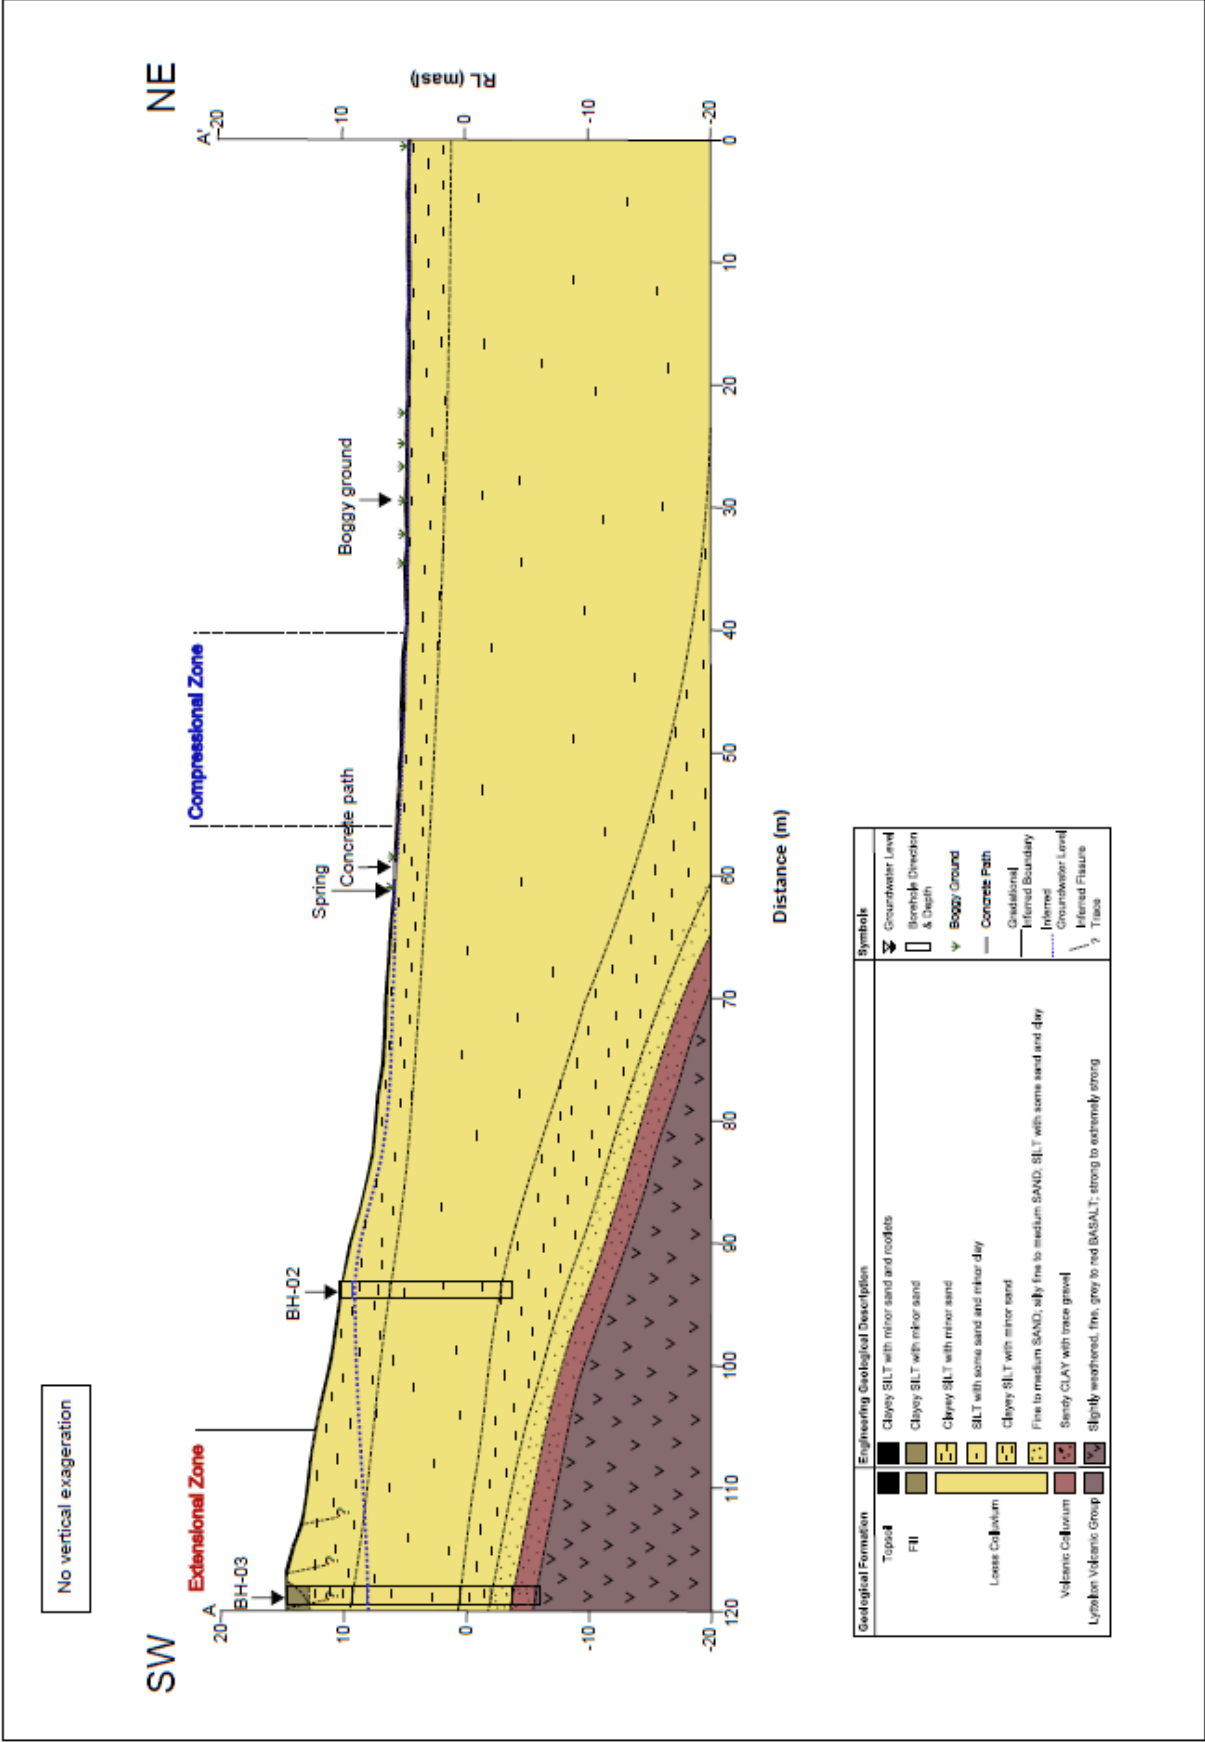
Figure 3.23 is the Centaurus Park cross-section with no vertical exaggeration. This cross-section was created from the topography line of the electrical resistivity geophysical survey of Stephen-Brownie (2012) and interpretation of the core delivered to the University of Canterbury by SCIRT. BH-03 and BH-02 were the closest boreholes to the cross-section line. Refer to Figure 3.21 for the cross-section line.

The groundwater level was interpreted from the groundwater levels recorded in BH-03 and BH-02, and from engineering geological mapping of the ground surface where there was surface water. The water levels in the boreholes may not represent the groundwater table, and instead may represent more saturated layers of loess-colluvium because the water content decreases in the clayey silt layer at depth. There were also artesian pressures encountered in BH-01, and the rise in the water level, as depicted in the model at BH-02, probably reflects groundwater pressure from depth. The water level at the ground surface in the valley floor could represent perched saturation of the surface soils, and might not indicate that the groundwater table is at the ground surface.

The extensional zone and compressional zones were located by correlation with the mapping done by Massey et al. (2013), and by the mapping done in the present study. The translational zone has been omitted because this presumes there has been a translational slide movement when there is little evidence to suggest that there has.

Figure 3.23: Centaurus Park cross-section. Refer to Figure 3.22 for cross-section line.

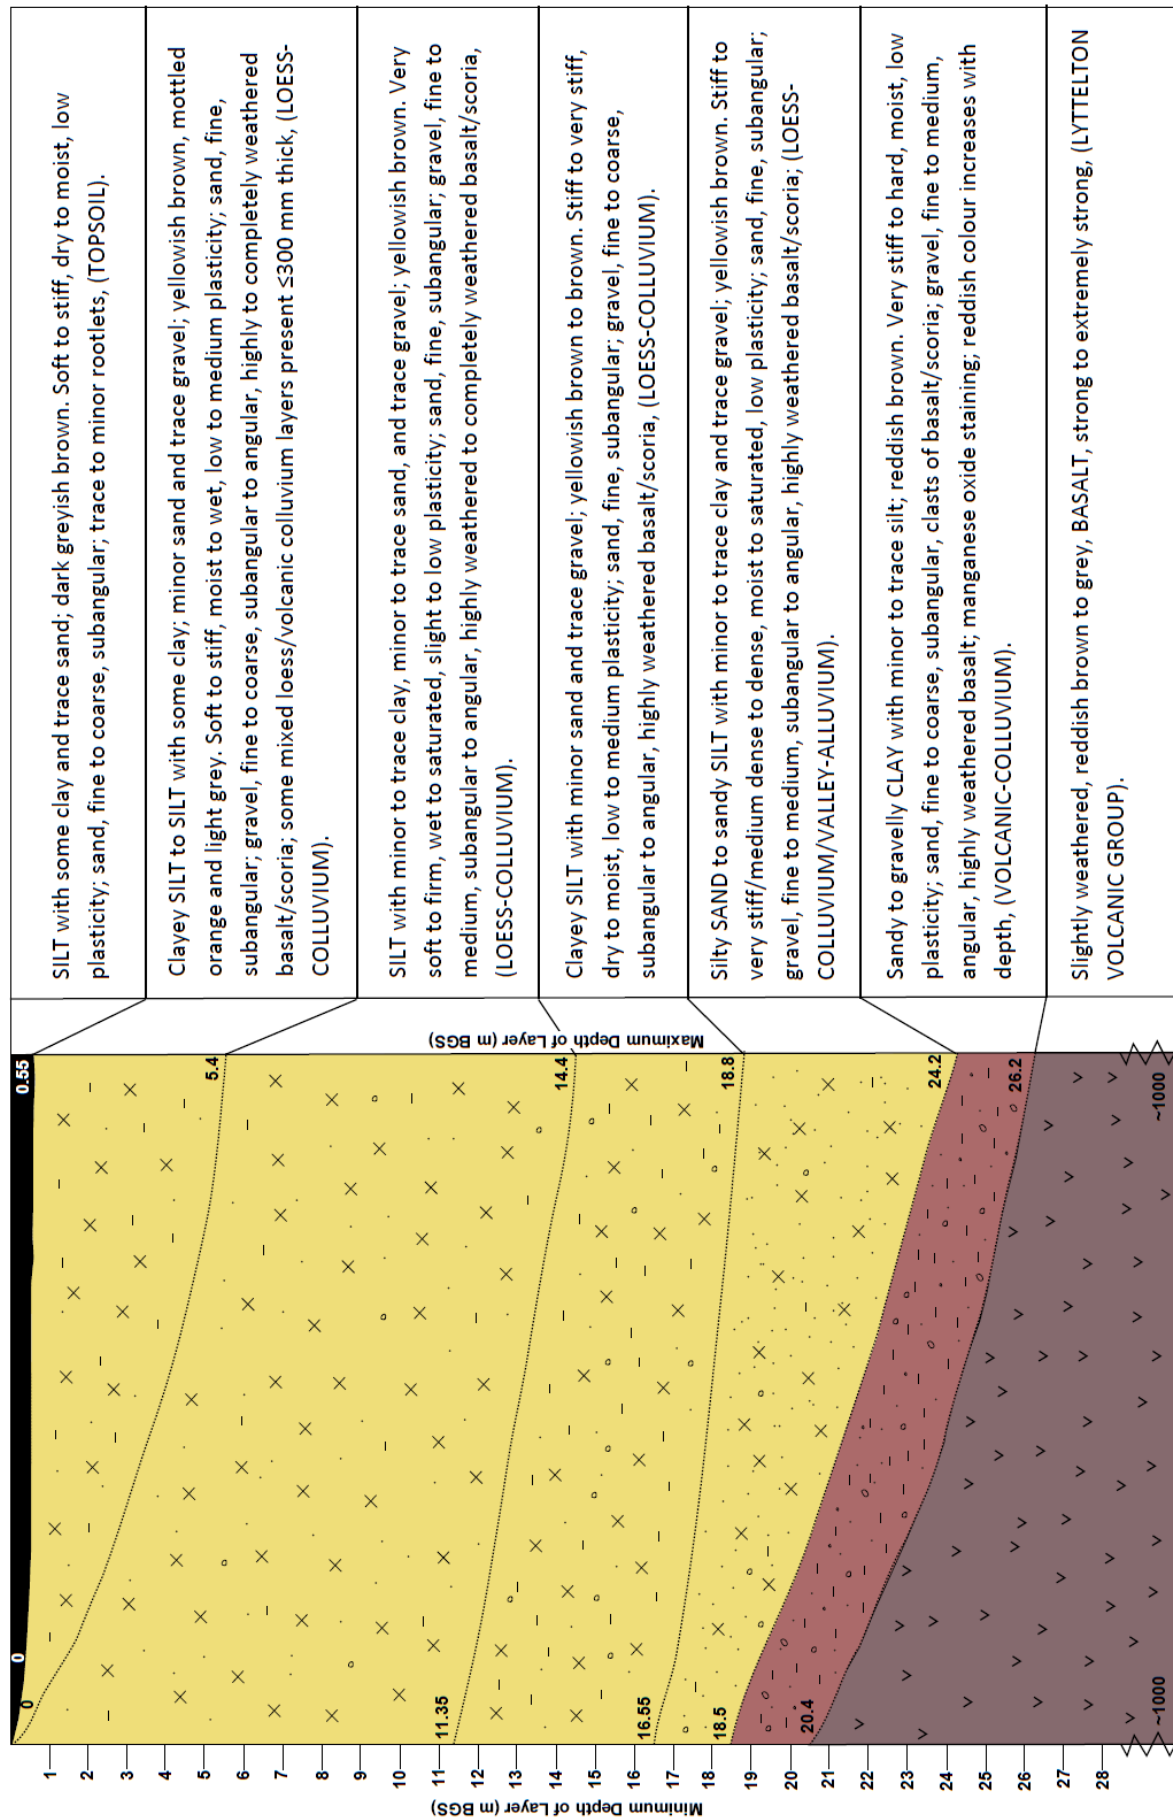
Figure 4.12: Soil profile for the area around Ramahana Road. The four layers of loess-colluvium are nominated as first layer, second layer, third layer, and fourth layer from below the topsoil layer to the volcanic-colluvium layer.

The Lyttelton Volcanic Group is found at a depth of 20.4m at Centaurus Park to 26.2m at 17 Ramahana Road. The joints in the basalt were recorded as subhorizontal, undulating-smooth, and closely spaced. The rock was also moderately to highly weathered and moderately strong, but because this is the surface of the Lyttelton Volcanic Group it is likely to have been more affected by weathering alterations than in deeper sections of the rock.

The Lyttelton Volcanic Group is overlaid by volcanic-colluvium. This layer contains a high proportion of weathered volcanic material mixed with some loess-colluvium, which becomes less prominent with depth. It is generally hard and moist. This layer was formed by the erosion of an upslope outcrop of volcanic rock and its subsequent downslope deposition.

The fourth layer of loess-colluvium is a sandy silt to silty sand. This facies can have layers of silty sand within it up to 3m thick, and interlayered deposits of silty sand and sandy silt ≤ 1 m thick. According to laboratory assessments the silty sand layers within this layer have a clay content of 3.4-8.6%, and a moisture content of 20%. This layer represents a period where the energy behind erosion/deposition was higher. The loessial material must have been reworked to a great extent in order to wash out most of the fine material.

According to laboratory assessments the third layer of loess-colluvium has a clay content of 16.6-26.9%, a moisture content of 8-10%, and a plasticity index of 12-15. Volcanic gravels are located in bands or spread throughout the deposit and they can be from fine to coarse sizing, but they tend to be of similar size in any particular area. This layer is dry to moist, and of generally fine particle-size distribution. The source of the loess may have been from a compact layer of primary loess, which is known to be of higher plasticity than the surface layer or parent layer.

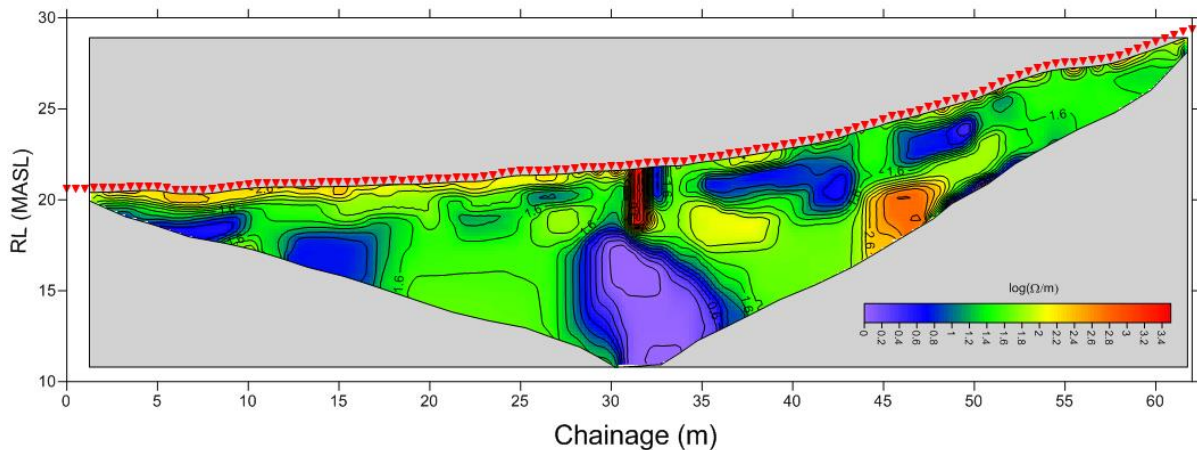
It was thought that if the soil from the compressional zone was found to have a greater dry density than the surrounding soil, then the observed compressional features would likely be a response to the underlying soil compacting during the Christchurch Earthquake. Figure 4.13 shows the electrical resistivity geophysical survey results that were introduced in Chapter 3. The area of high resistivity in the centre of the model is thought to represent an area of soil compression and a corresponding decrease in porosity, because its location correlates to the compressional zone at 17 Ramahana Road.

Figure 4.13: The electrical resistivity geophysical survey model for 17 Ramahana Road.

The density tests in the compressional zone show that the soil dry density is similar at S1 to S3 (from 1657.7 kg/m³ to 1674.6 kg/m³), but it increases to 1793.67 kg/m³ 2m upslope at S4. 2m further upslope at S5 the dry density decreases to 1715.7 kg/m³, which suggests that the dry density begins to decrease with farther distance upslope, and this is what would be expected from the electrical resistivity geophysical survey in Figure 4.13 and from the

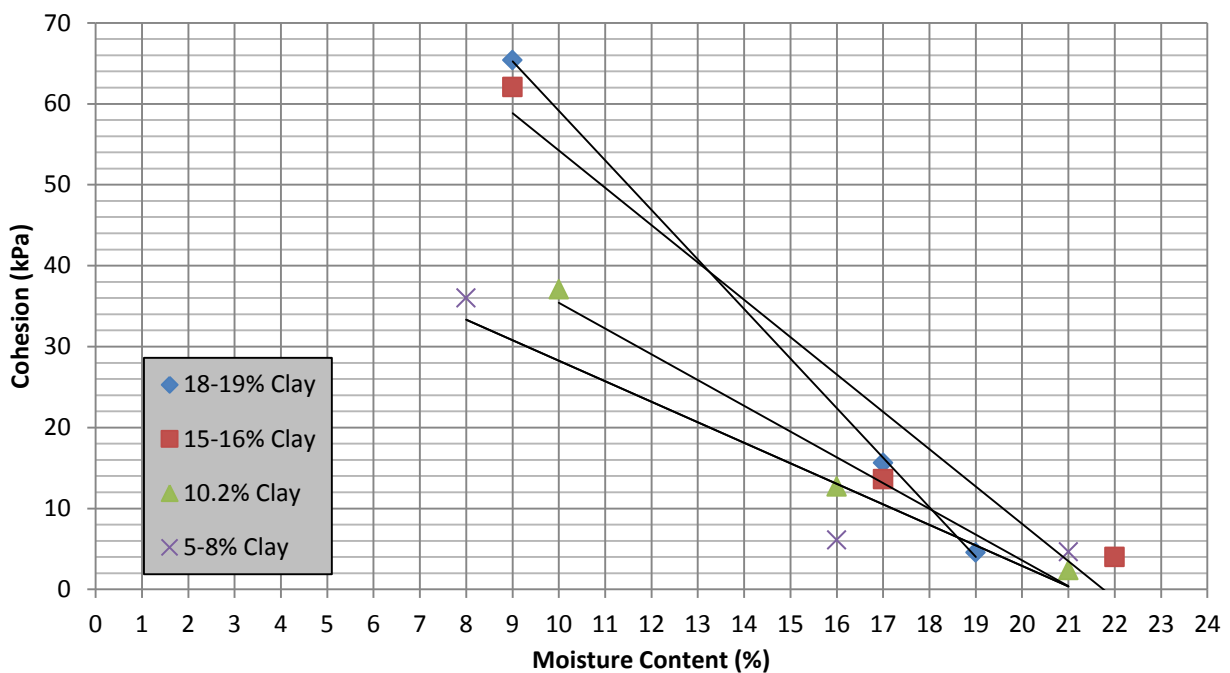
Figure 4.14 shows how the cohesion of the loess-colluvium decreases with increasing moisture content. The amount of clay has influence over the cohesion value at lower moisture contents, but at higher moisture contents its influence is reduced. At a moisture content of 8-10% the higher the clay content, the higher the cohesion; the same trend is seen at a moisture content of 16-17%; however this is to a lesser extent.

At moisture contents of 19-22% (i.e. above the plastic limit) the influence of clay content is unobservable, and the cohesion values are scattered at or below 5 kPa. This could be because the test is a drained test, which causes the moisture to drain from the sample during testing. The samples with less clay are coarser than the other samples tested, and therefore have a greater porosity and permeability. This would make these samples easier to drain when loaded, and it was noticed that more moisture was left in the shear-box test during testing of the coarser samples. The effects of drainage would have less of an effect on the samples with a finer grain-size, but all would have been affected to a certain degree. In hindsight moisture content tests should have been carried out on the samples post-test to quantify this loss of moisture.

Figure 4.14: The cohesion with moisture content for soil samples of various clay contents as tested by the direct shear-box strength test. Trendlines are linear.

This relationship shows that the strength of the loess-colluvium samples in terms of cohesion is dependent on the moisture content. This suggests that where the soil profile has been found to be at a higher moisture content in natural moisture content tests is where the soil would be more likely to deform under cyclic loading. At higher moisture contents of >15% the deformation is likely to be of the ductile/plastic deformation style (following Hughes, 2012).
